Hypervelocity Impact of Composite Overwrapped Pressure Vessel (COPV) and Comparison to a Numerical Model

Matthew Garcia¹; Bruce Alan Davis²; Joshua Miller, PhD¹ ¹CASSMAR, University of Texas at El Paso, 500 W. University Ave, El Paso, TX, 79912 ²Jacobs, NASA Johnson Space Center JETS contract, 2224 Bay Area Blvd., Houston, TX, 77058

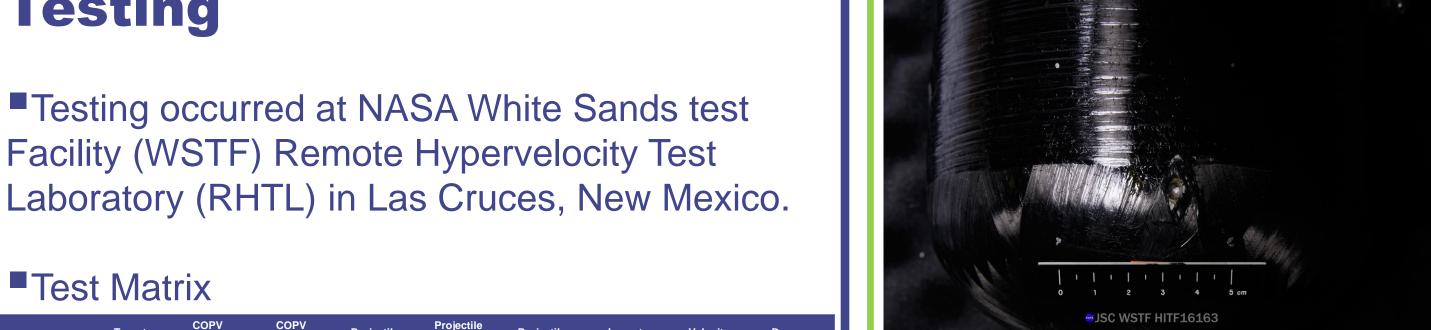
HITF16163, Pressurized test, Pass

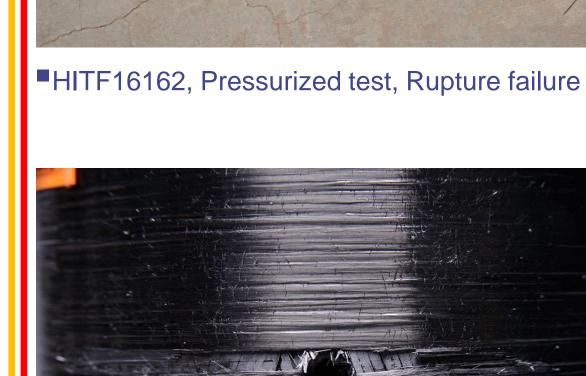
HITF16169, Pressurized test, Venting failure

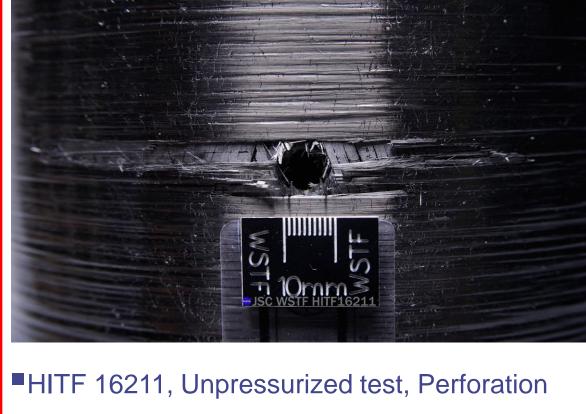
HITF 16394, Unpressurized test,, Perforation

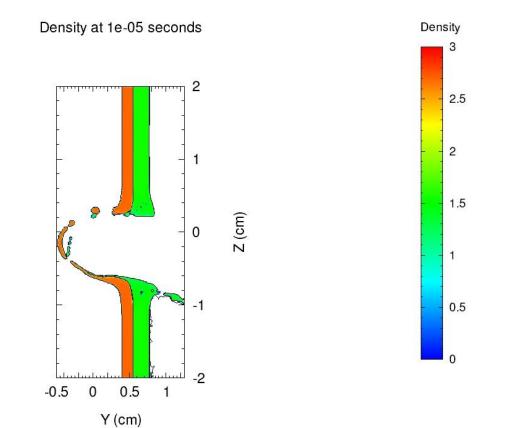
CTH simulation of HITF16212; Result: Fail

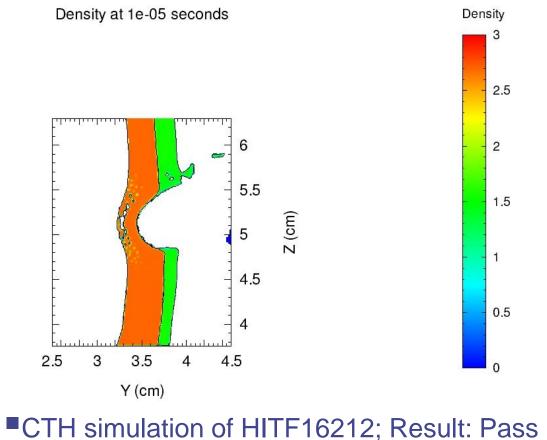
HITF 16212, Unpressurized test, Pass
